INSTALLATION RESTORATION PROGRAM

123rd AIRLIFT WING
KENTUCKY AIR NATIONAL GUARD
STANDIFORD FIELD
LOUISVILLE, KENTUCKY

FIRST QUARTERLY MONITORING REPORT FOR THE FORMER FIRE TRAINING AREA DELIVERABLE 2B

JANUARY 1998

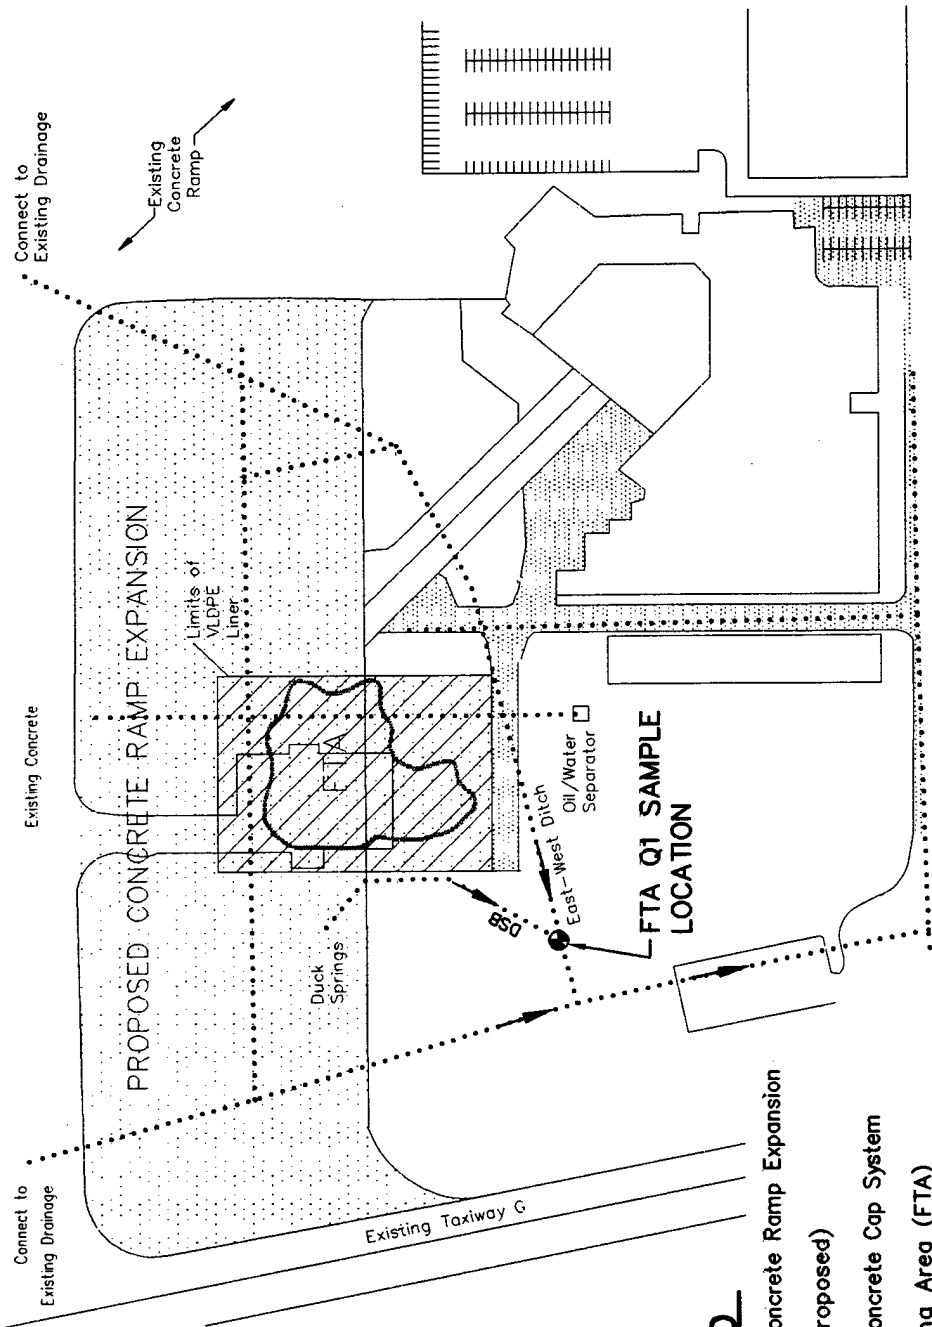
Figure
2

FTA SAMPLE LOCATION

On 25 May 1996 one sample was collected from the drainage culvert as required by the Sampling and Analysis Plan (Figure 2). A duplicate sample and matrix spike/matrix spike duplicate samples were also collected. The original sample and the duplicate sample were labeled with the identification numbers of FTA-1 and FTA-2, respectively. The matrix spike/matrix spike duplicate samples were labeled as such for laboratory identification. A trip blank sample accompanied the samples during shipment and was analyzed for VOCs utilizing methods 8010 and 8020. Table 1 summarizes the samples collected and analyses performed. Sampling activities were recorded in the project log book, a copy of which is provided in Appendix I. The sample identification numbers, time of collection and associated analytical methods were recorded on the Chain of Custody (CoC).
